US. Power Gen- General Electric Frame 5 Gas Turbine

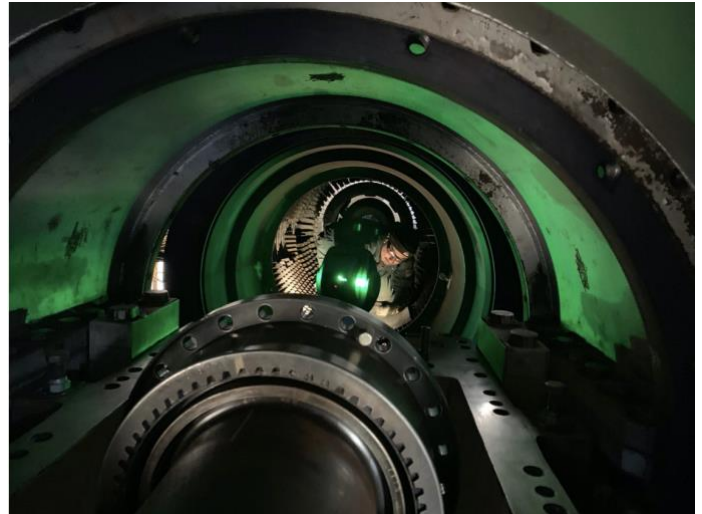
The General Electric Frame 5 gas turbine was brought down by an unscheduled outage. The turbine was experiencing a rub on the rotor and buckets along the compressor casings. From these issues, it was determined that an internal alignment was needed to return the unit to its optimal operating conditions. The turbine was an outside unit, which required the work to be done on a small time window in the early hours of the morning in order to avoid any thermal expansion caused by the sun. The unit was located on a large power barge off the coast of Brooklyn NY. This required the implementation of a measurement system that was able to account for the vibrations created by the wake of passing boats. The underlying factors required the work to be done using a laser alignment system.

ACQUIP was at the job site within 24 hours equipped with a FARO laser tracker system. The turbine was checked for its pre-alignment condition, and an initial set of measurement were quickly and effectively performed. The initial set of data was recorded at the bearings, compressor casings, and turbine section which allowed for the problem to quickly be identified. ACQUIP was able to calculate the required adjustments in order to correct the clearance issues that the turbine was experiencing.
