## Machine Train Shaft Alignment

The client is an electrical submersible pump (ESP) manufacturer for oil wells located in Dammam, Eastern Province, Saudi Arabia.

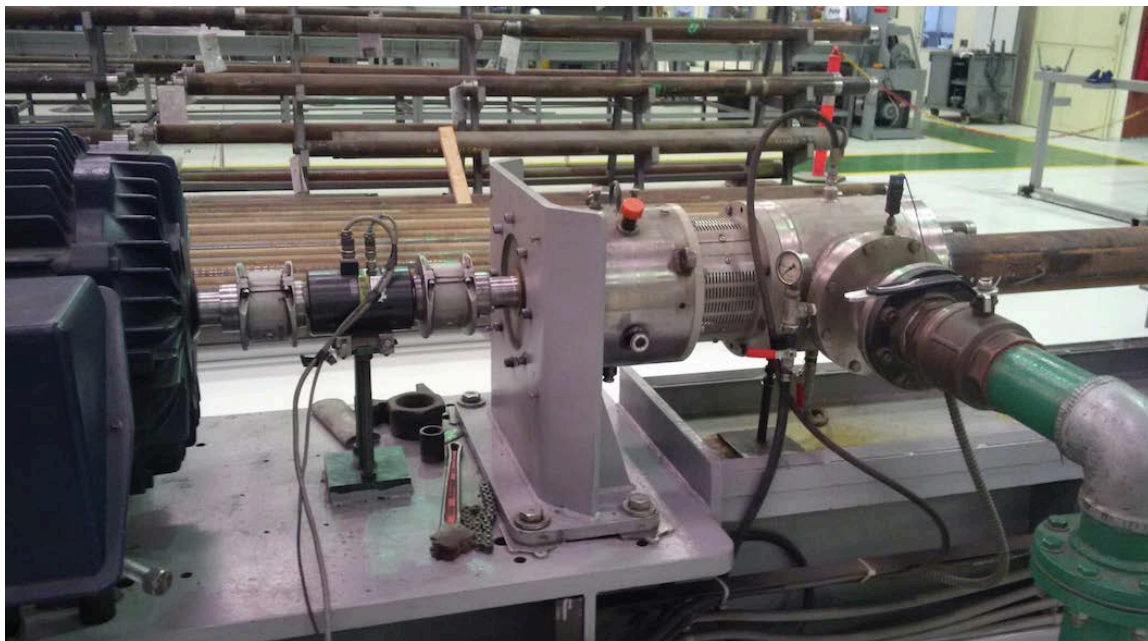
Figure 1. Machine train setup.

The old torque cell was damaged due to vibration and was replaced by a new torque cell. The whole machine train was experiencing severe vibration issue and has been the number one cause of downtime and parts replacement. With the new torque cell installed, the clients' alignment team performed alignment but the vibration was not solved, and there were unacceptable alignment results. This machine train is used to test electrical submersible pumps (ESP) for oil wells. The pumps need to pass the quality check using the machine train as a test bed before shipment to the end users. The client wanted to get the machine train up and running as soon as possible as there are several pumps waiting for testing. Further delay should be avoided at all cost since there is no backup equipment. Due to a backlog of pumps awaiting testing, and with the shipment deadline looming, ACQUIP was contacted to do the laser alignment.

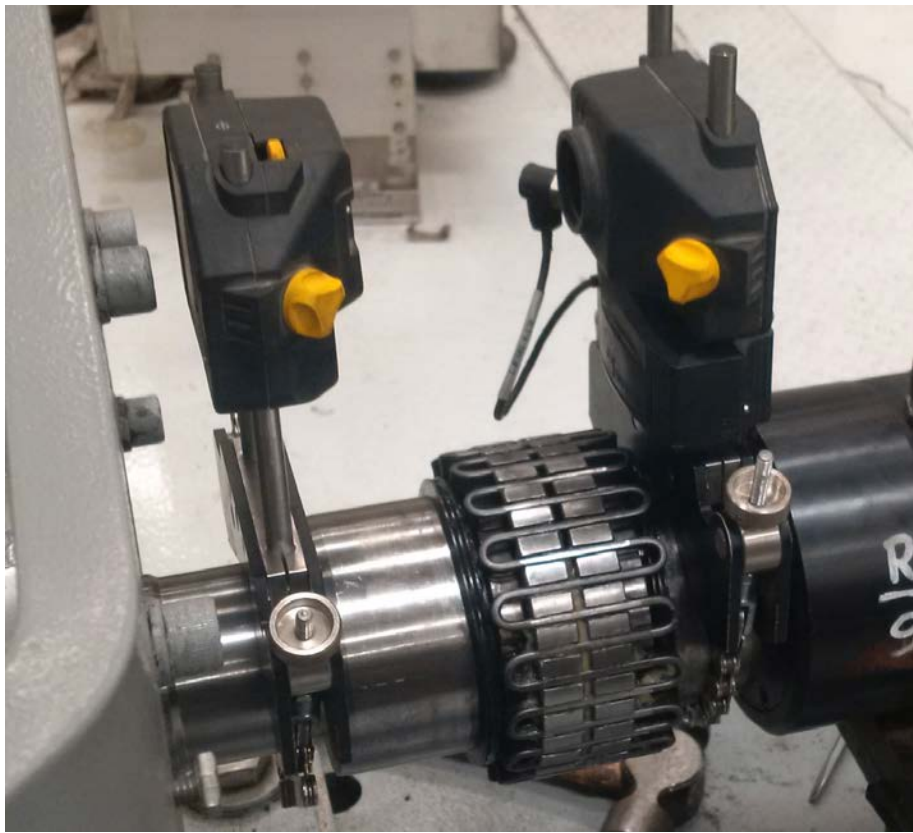
**Figure 2. Setup for taking readings between thrust chamber and torque cell.**

After these readings were recorded, as found readings between torque cell and motor were taken and recorded. The result was the torque cell was misaligned to the thrust chamber. The motor was also misaligned to the torque cell. Alignment corrections were then carried out on the torque cell and it was observed that the torque cell base was flimsy/weak. Due to unstable torque cell base, it greatly affected the alignment corrections and readings. Also, there is a greater tendency for alignment to change in a short time due to instability issue of the base.

Recommendations were given to the client to modify the base since it is one of the suspected sources of vibration and misalignment. ACQUIP team managed to align the torque cell to the thrust chamber.

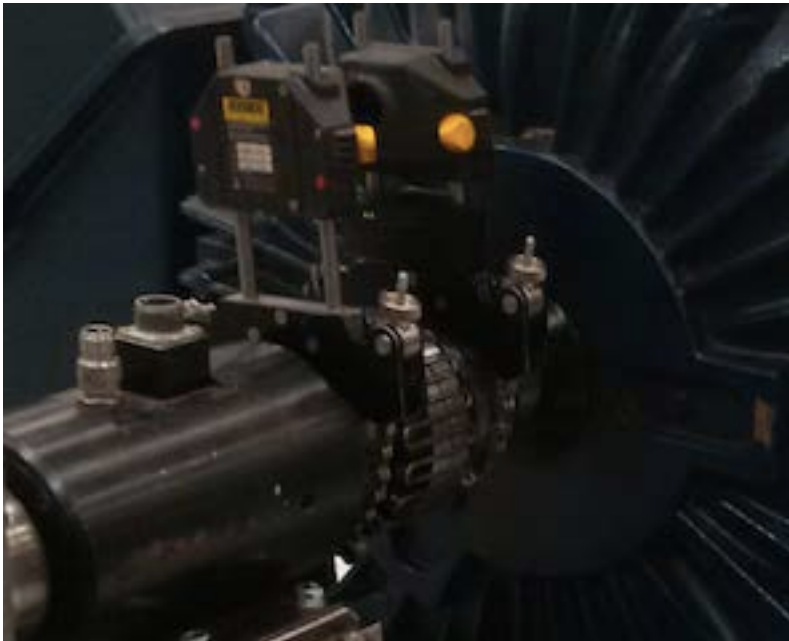
**Figure 3. Setup for taking readings between torque cell and electric motor.**

It was discovered that all feet of the motor had a bent foot. Corrections were made and ensured that soft foot was eliminated. After aligning the motor to the torque cell, final alignment check was performed on the whole machine train. The team found out that the torque cell was misaligned to the thrust chamber again. The first observation was then confirmed that the flimsy support/base of the torque cell influenced the alignment readings and correction. Worked stopped and the problem was discussed to the responsible personnel. The top management got involved and

the situation was assessed. It was then decided that a new base should be made.

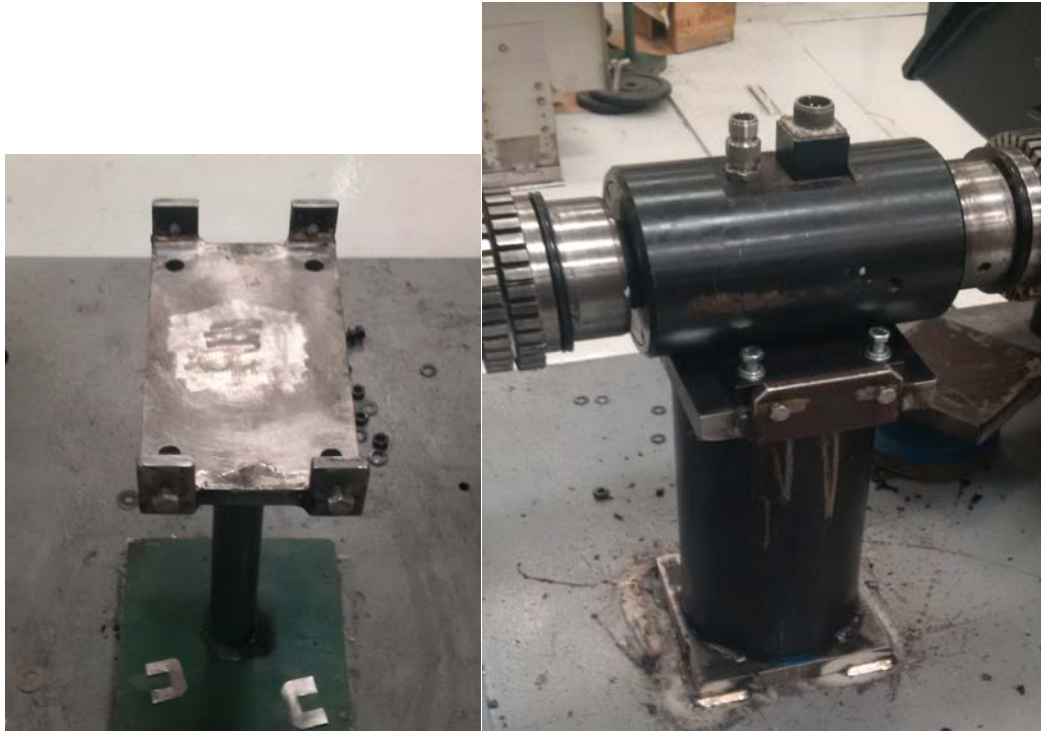
ACQUIP team went back to site when the new base was installed. The new base was more rigid and stable than the old one. Refer to Figure 4.

**Figure 4. (Left) Old torque cell base. (Right) New torque cell base.**

The old torque cell base was flimsy/weak resulting to instability during operation thereby experiencing vibration and misalignment. Due to the long-term effect of the unstable base to the machine train, it affected the couplings and bearings as evident during alignment check. The coupling had a +/- 2 mils runout and the bearings had clearance/play that contributed the vibration. All motor feet were bent due to improper alignment procedures that try to compensate for the instability of the torque cell base. Some malpractice on shims like using washer and stacking more than necessary to attain the required height was observed. The thrust chamber was observed to be improperly supported despite the pressure, weight, high RPM and all forces acting on it during operation. All of these factors summed up the severe vibration issue experienced by the client and constant replacement of parts and downtime.

With a stable torque cell base, as found readings were acquired again between the thrust chamber and torque cell. Custom shims were made to accommodate the small footprint of the base that comes with the torque cell. Once satisfied with the corrections made and repeatable readings were obtained, the torque cell was then locked and torque down to its final position.
