Marine Cardan Shaft Alignment

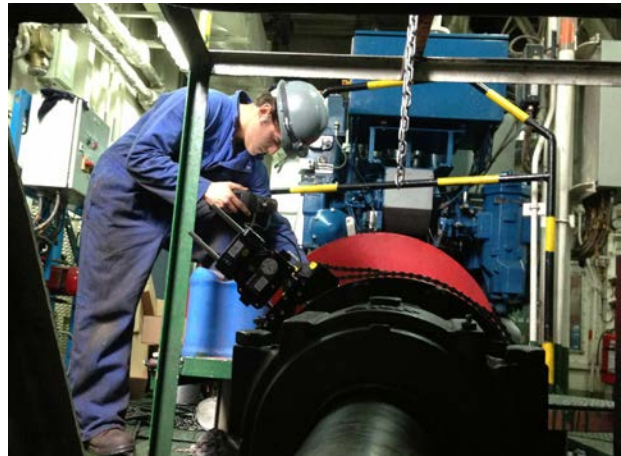
P&O Marine had a high vibration issue on a pusher tug. The vibration was so intense that the bearing supports were consistently damaged during operation. It was determined that the high vibration and damage was most likely caused by an alignment issue. To complete the cardan shaft alignment it is necessary to align multiple components, but it had to be done quickly so the tug could return to operation. A cardan shaft machine train alignment had to be performed to meet the requirements of the project.

ACQUIP was contacted to perform the cardan shaft laser alignment on the pusher Tug. We had to read each of the cardan shaft couplings and view the alignment as a whole. The axial spacing of each cardan shaft was checked. All cardan shaft positions and pedestal bearings were checked to compare to the shaft arrangement drawing. It is important that the axial spacing is within tolerance as well as the angles that exist at each cardan shaft knuckle. This is critical to ensure smooth operation of the cardan shaft machine train.

ACQUIP Alignment Engineers determined that there was residual angle between the motor and Azimuth gearbox on both port and starboard drives. The cardan shaft drive system was modeled in the computer; a theoretical move was made on the pedestal bearings to simulate corrections. Once it was confirmed that corrections could be made to balance the angle at each knuckle, the chock fast was removed and alignment corrections were made while tracking the alignment at each of the 4 cardan knuckles. After the angles were balance and the bearings were chock fasted in place, sea trials were performed that confirmed the alignment dramatically reduced the vibration experienced on the pusher tug.
