MOTOR – COMPRESSOR Laser Shaft Alignment

The client is a large industrial gas producer company located in Jubail Industrial City, Eastern Province, Saudi Arabia.

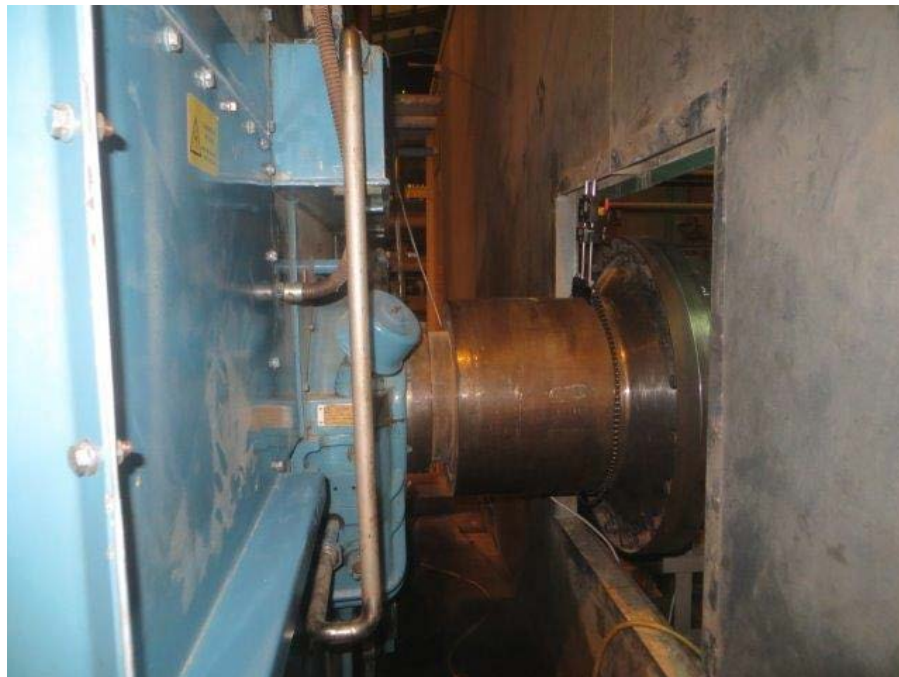
Figure 1. Electric motor on the left with spacer shaft connection thru the sound dampening enclosure.

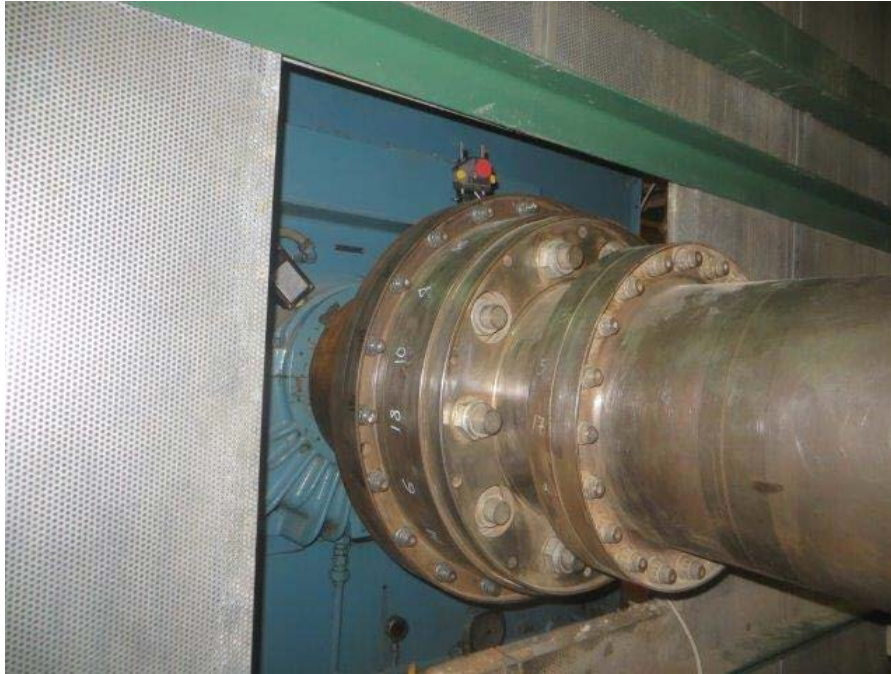
Figure 2. One end of the spacer shaft coupling attached to the motor.

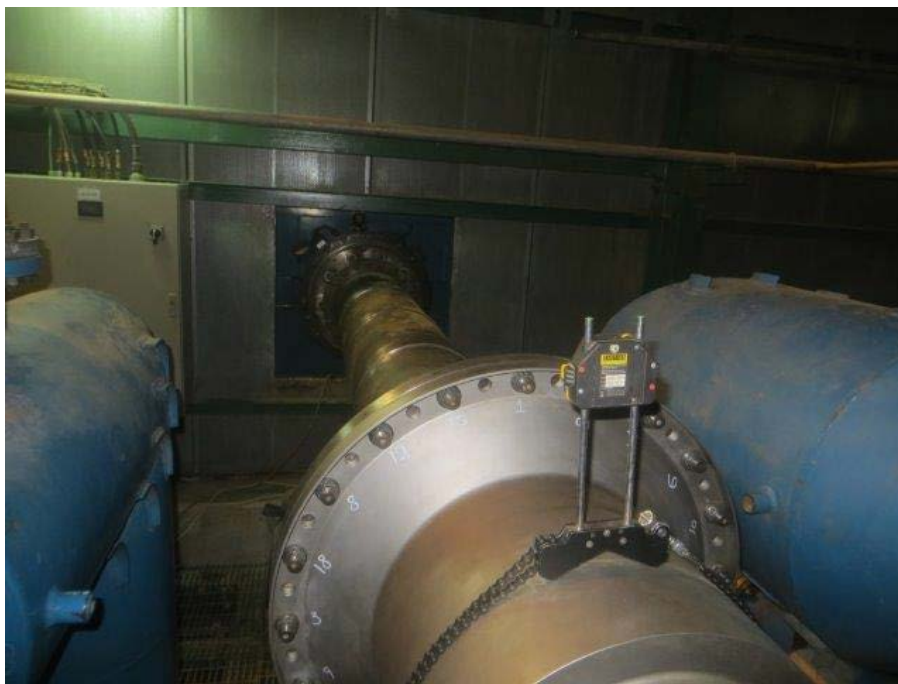
Figure 3. Setup of the laser equipment on one coupling of the spacer shaft facing the motor.

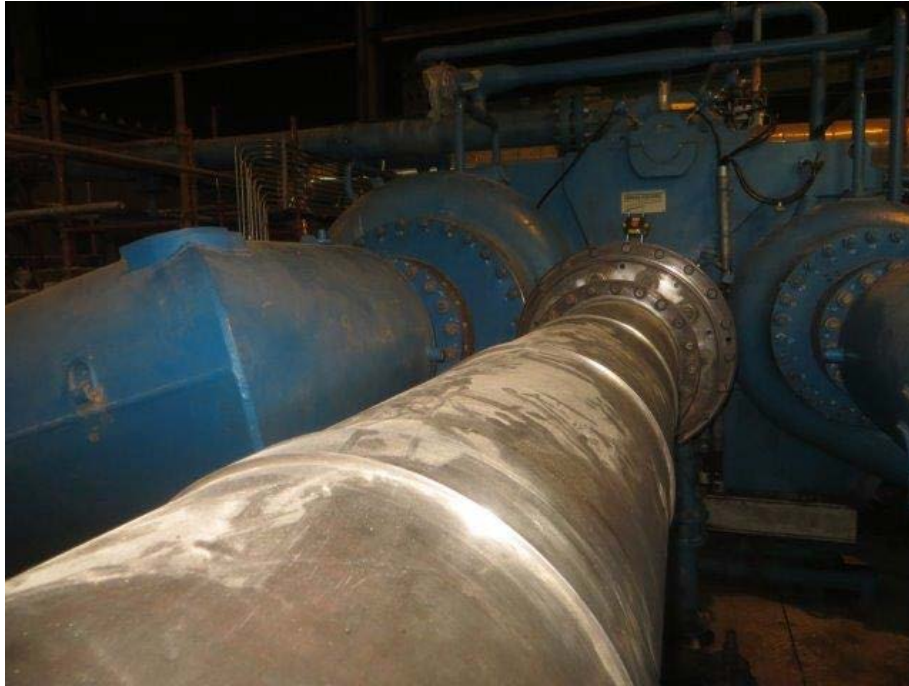
Figure 4. Setup of the laser equipment view from the motor end looking towards the compressor.
