## Seabulk Towing Cardan Shaft Alignment

### PROJECT SCOPE

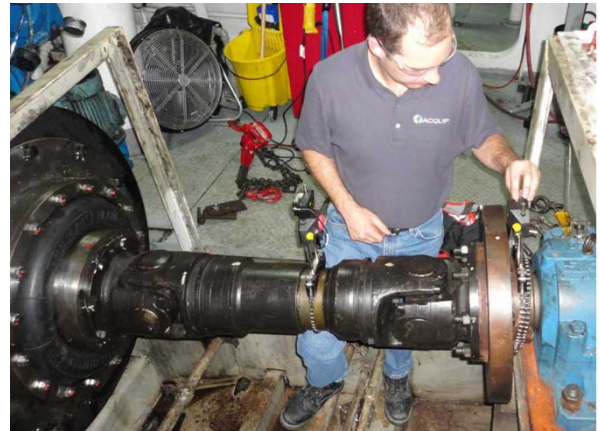
ACQUIP Alignment Engineers determined that the axial distance on the port side cardan shaft drive was incorrect. In addition, the angles exhibited at each cardan shaft knuckle were not equal and at a more extreme angle than is allowable. By comparing all positions to the shaft arrangement drawing, it was determined that the pedestal bearing was in the wrong location. The cardan shaft drive system was modeled in the computer, a theoretical move was made on the pedestal bearing to its correct location. When this move is accomplished it will correct the axial distance and equalize and reduce the angle at each knuckle. This will correct the alignment issue on the cardan shaft drive and should correct the vibration issue. It will also save money on Vulcan couplings!
