Express (Theoretical Tops On) Internal Laser Alignment

PROJECT SCOPE

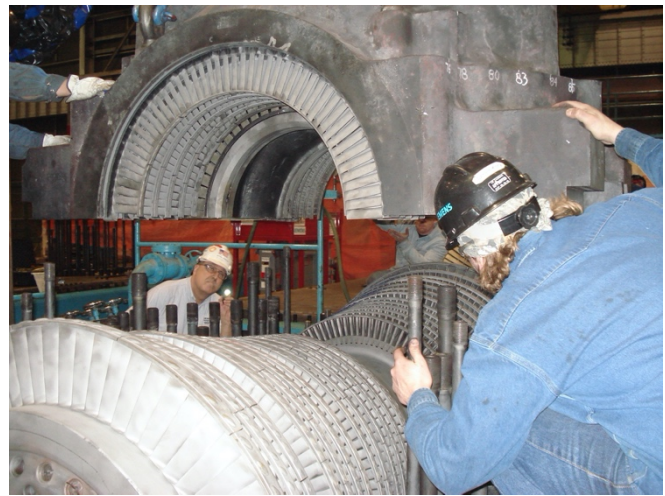
ACQUIP was contacted during a major holiday to mobilize to the job site. ACQUIP was able to start taking data immediately. We used our express alignment process and proprietary bracketing to record high quality data. Data is taken while the internal components of the turbine are being inserted and removed from the unit.
