Faro Laser Tracker Hull Movement Study

PROJECT SCOPE

Grand Bahamas Shipyard hauled out a tanker that was badly damaged. Half of the steel had to be replaced on the bottom of the outer hull. The shipyard needed a way to determine that the large amount of steel replacement was not going to affect the integrity of the hull. It was determined that the best way to determine the hull movement was to measure the hull at several instances throughout the course of the steel replacement.

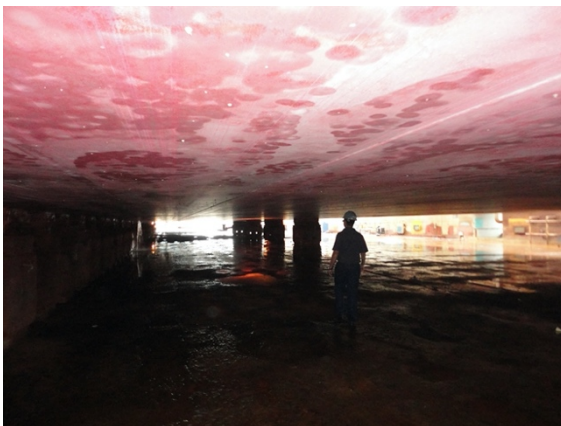
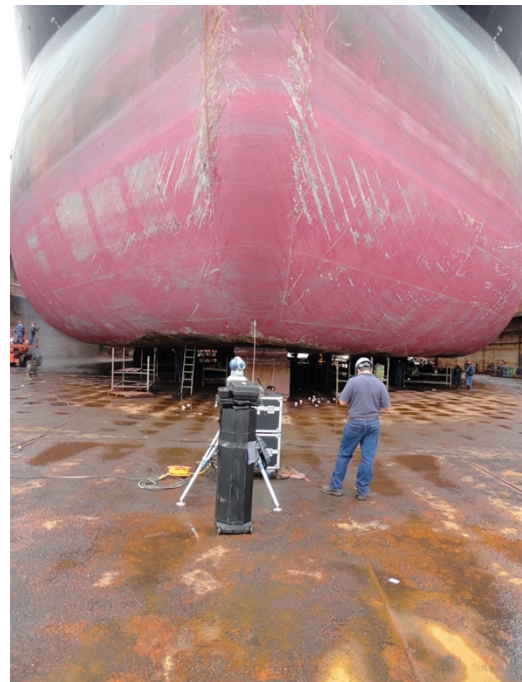
ACQUIP was contacted to determine and execute the best process to analyze the hull movement over a 60-day period. We decided to use the FARO ION Laser Tracker to establish a baseline and then measure the deviation of the points from the baseline. Fixed targets were set up as references to use through the project. Hull targets were welded to the vessel to track throughout the steel replacement. ACQUIP visited the site on 4 separate occasions to measure the hull with the FARO laser tracker and recorded all data into the computer.

ACQUIP Alignment Engineers determined that no significant movement occurred during the steel replacement process. Grand Bahamas shipyard was assured that there were no issues with the shape of the hull before launching vessel. ACQUIP was able to provide a cost effective solution to quickly determine the hull movement profile over a long period of time.
