FARO Laser Tracker Turbine Shell Distortion Study

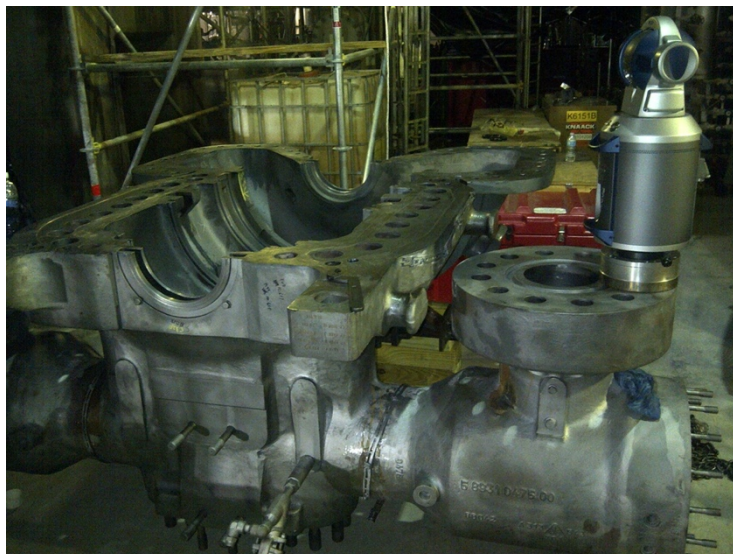
ACQUIP was able to quickly mobilize to the jobsite with a FARO ION Laser Tracker. We were able to quickly take over 3,000 measurement points on both the upper and lower half of the horizontal joint. The maximum measured shell deflection matched exactly what the plant recorded from the feeler gauge readings. The CAD files were created and fed into a filed machining system to correct the horizontal joint surface.

ACQUIP Alignment Engineers determined the deflection accurately and quickly using the FARO ION Laser Tracker. PCS nitrogen was then able to use the data to quickly fix the issue with the steam turbine and return it to service.
