Machine Train Alignment

PROJECT SCOPE

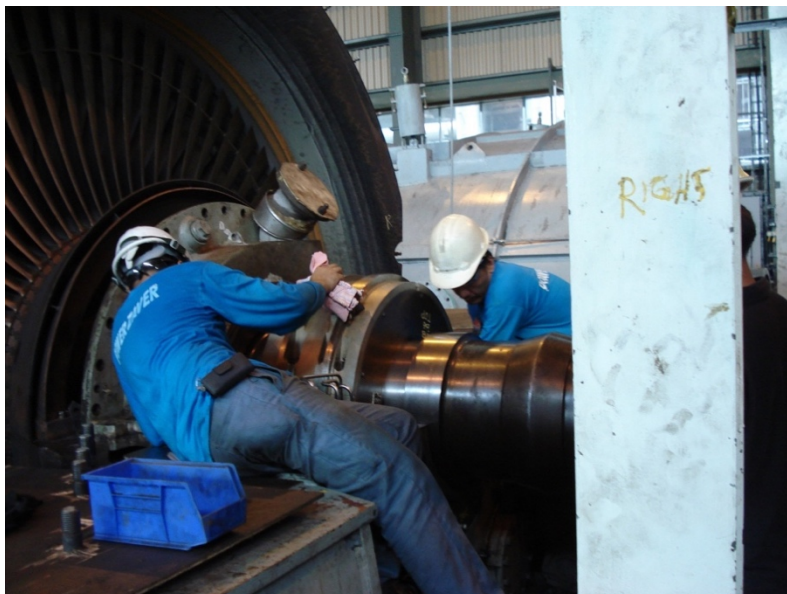
ACQUIP was contacted to perform the machine train laser alignment on the steam turbine. We had to read each of the couplings and view the alignment as a whole. All alignment targets were considered. A small horizontal and vertical move was performed on the generator only, to get both couplings to within excellent alignment tolerance.

ACQUIP Engineers helped GE in solving a complex alignment problem with the minimal amount of moves possible and without moving the bearings. The unit was brought back into service quickly and without creating and hot work in a nuclear environment.
