Altamira II Mitsubishi 501F Gas Turbine.

PROJECT SCOPE

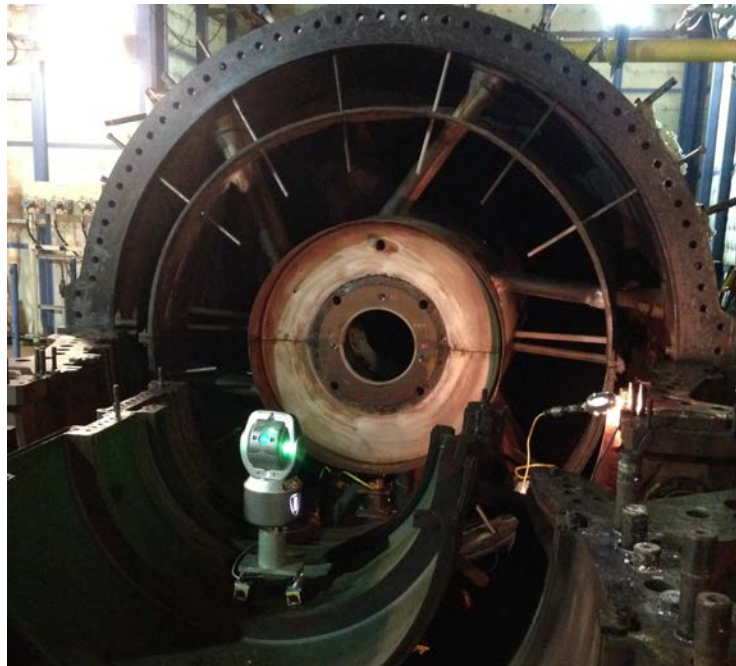
ACQUIP was at the job site within 24 hours equipped with a FARO laser tracker system. The turbine was checked for its pre-alignment condition, and an initial set of measurements were quickly and effectively performed. The initial set of data was recorded at the compressor, combustion and turbine casings as well as the bearings and torque tube. The readings enabled the problem to be quickly identified. The exhaust bearing was severely misaligned and upon further inspection, the engineers found that the support struts were slightly bent. ACQUIP was able to calculate the precise and required adjustments in order to correct the clearance issues that the turbine was experiencing.
