Faro Laser Tracker CNC Axis Rail Alignment

PROJECT SCOPE

Mitsubishi Power Systems was in the process of rebuilding a CNC after a malfunction. As part of these repairs, the APC, Z, X, and Y axis guide rails needed to be replaced. To ensure that the rails were aligned properly Mitsubishi Power Systems contacted ACQUIP to assist in the alignment measurements and adjustments of the guide rails.

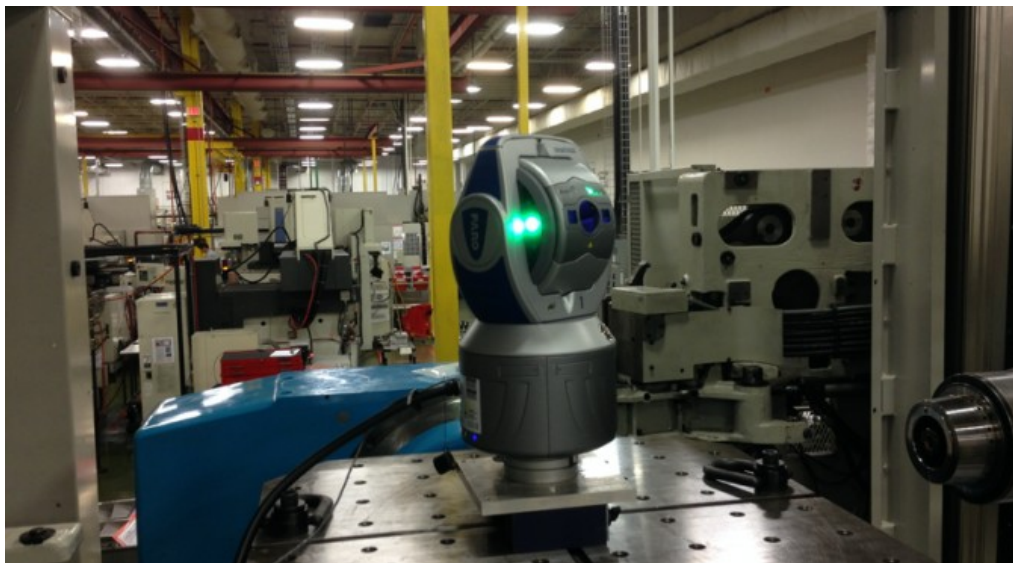
ACQUIP Alignment Engineers measured the guide rail alignment conditions quickly and accurately using the FARO Vantage Laser Tracker. ACQUIP was then able to direct Mitsubishi Power Systems to quickly fix the alignment on the guide rails and continue the unit repairs.

ACQUIP rapidly mobilized to the jobsite with a FARO Vantage Laser Tracker. ACQUIP was then able to quickly take measurements on the alignment conditions and immediately recommend changes and adjustments to improve the alignment conditions to within tolerance. Parallelism, perpendicularity, angularity, flatness, and straightness of the guide rails were compared and corrected as needed.
