Siemens - Westinghouse 501 FD Gas Turbine Internal Laser Alignment

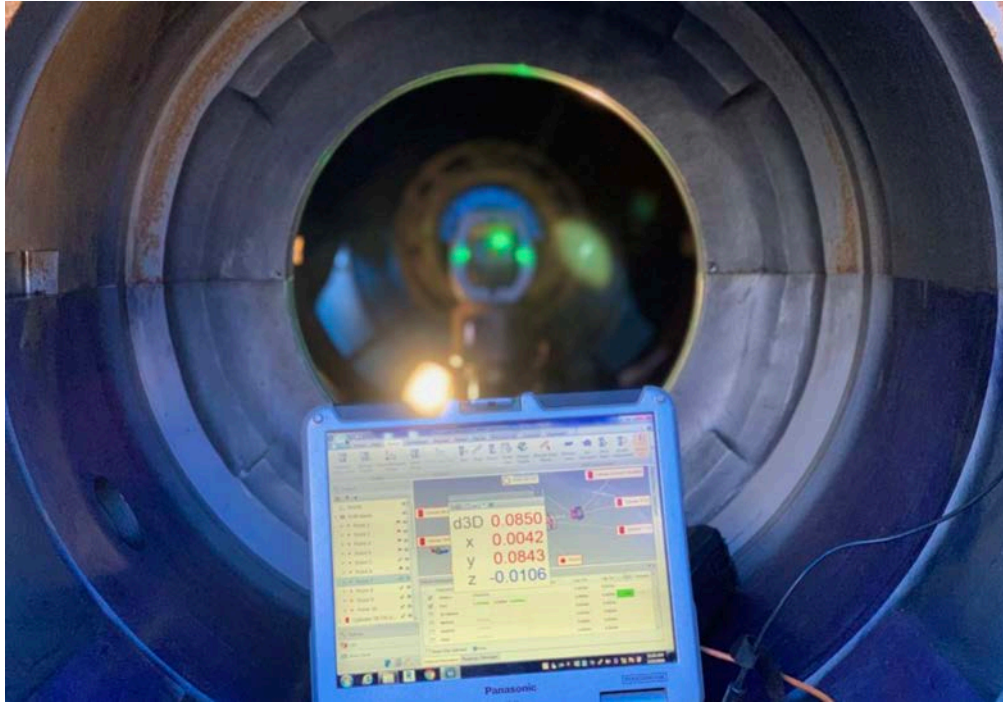
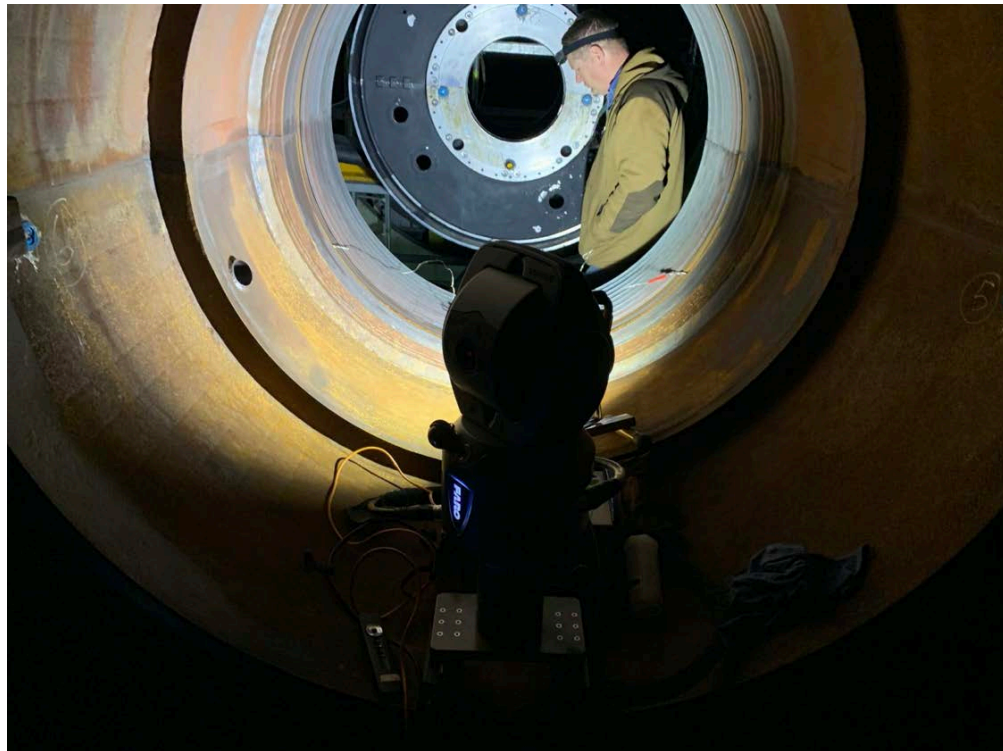
ACQUIP was able to mobilize to the job site when the alignment was ready to be performed. The turbine was checked for its pre-alignment condition and Acquip was able to start taking data immediately. A laser was shot from the inlet to the exhaust bearing and all measurements were recorded for the bearings, turbine section, torque tube and compressor section. ACQUIP was able to determine that a move was required on both the inlet and exhaust bearings in order to correct the torque tube and compressor section clearances.
